JULY–AUGUST 1996

Dubrovnik-bound Flight Crew's Improperly Flown Nonprecision Instrument Approach Results in Controlled-flight-into-terrain Accident

On April 3, 1996, the crew of the U.S. Air Force CT-43A (Boeing 737-200) was flying a nondirectional radio beacon (NDB) approach in instrument meteorological conditions (IMC) to Runway 12 at the Cilipi Airport, Dubrovnik, Croatia, when the aircraft collided with a 701-meter (2,300-foot) mountain. All six crew members and all 29 passengers were killed in the accident.

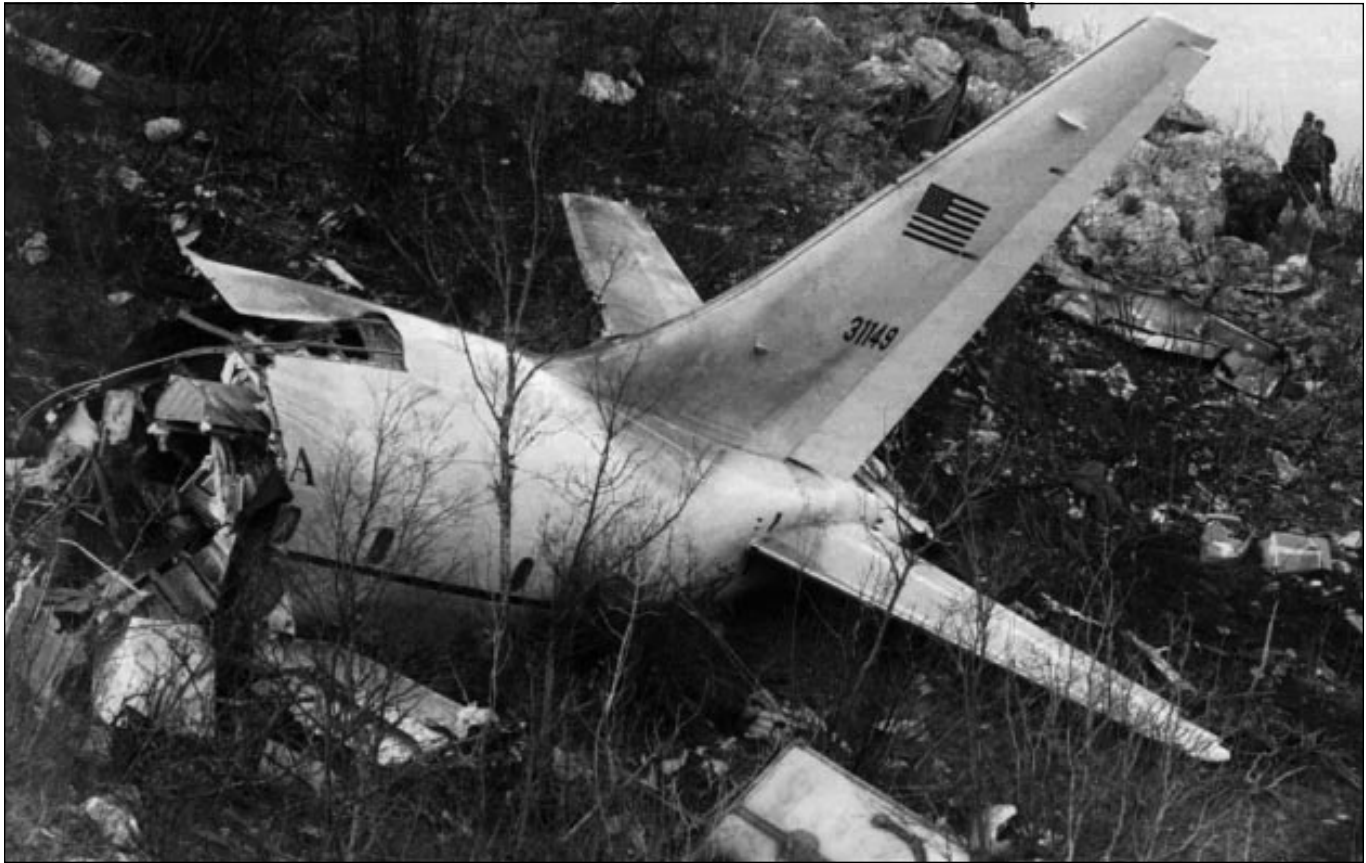
Wreckage of the U.S. Air Force CT-43A that crashed near Dubrovnik, Croatia, on April 3, 1996, killing U.S. Department of Commerce Secretary Ron Brown and all 34 others on board.

Examination of the wreckage revealed fire damage that was characteristic of postimpact fire. Fractured surfaces exhibited characteristics of overload that were consistent with high-energy impact with the ground. There was no preimpact failure or separation of the aircraft structure. Evidence of fatigue or corrosion that could have precipitated preimpact failure was not found on any major component.”

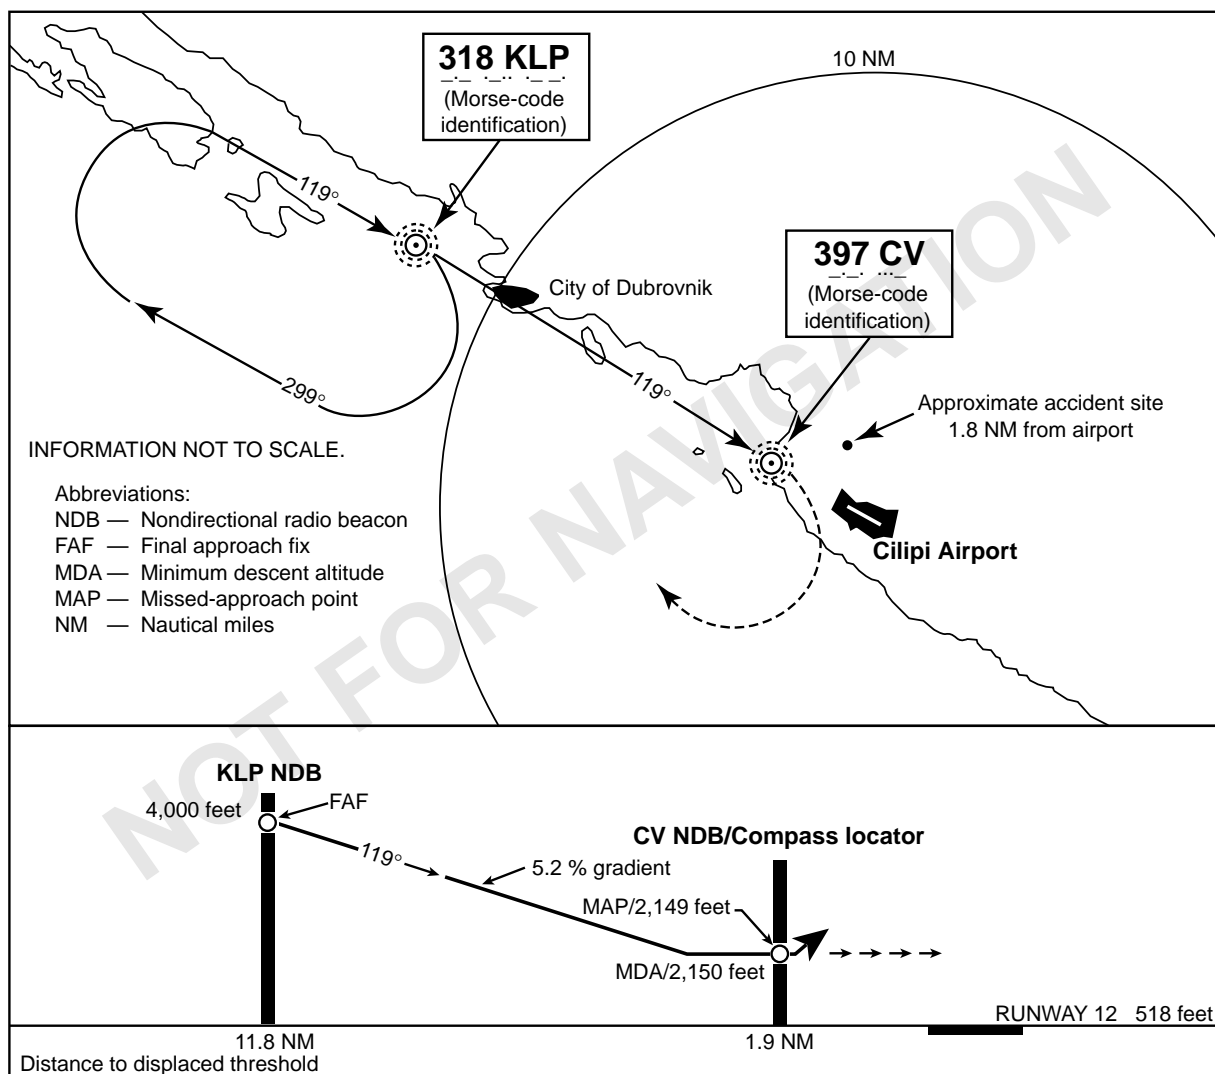
Figure 2

At the time of the accident, the NDB approach to Runway 12 (Figure 2) was the only instrument-approach procedure

Illustration of NDB Approach to Runway 12, Cilipi Airport, Dubrovnik, Croatia

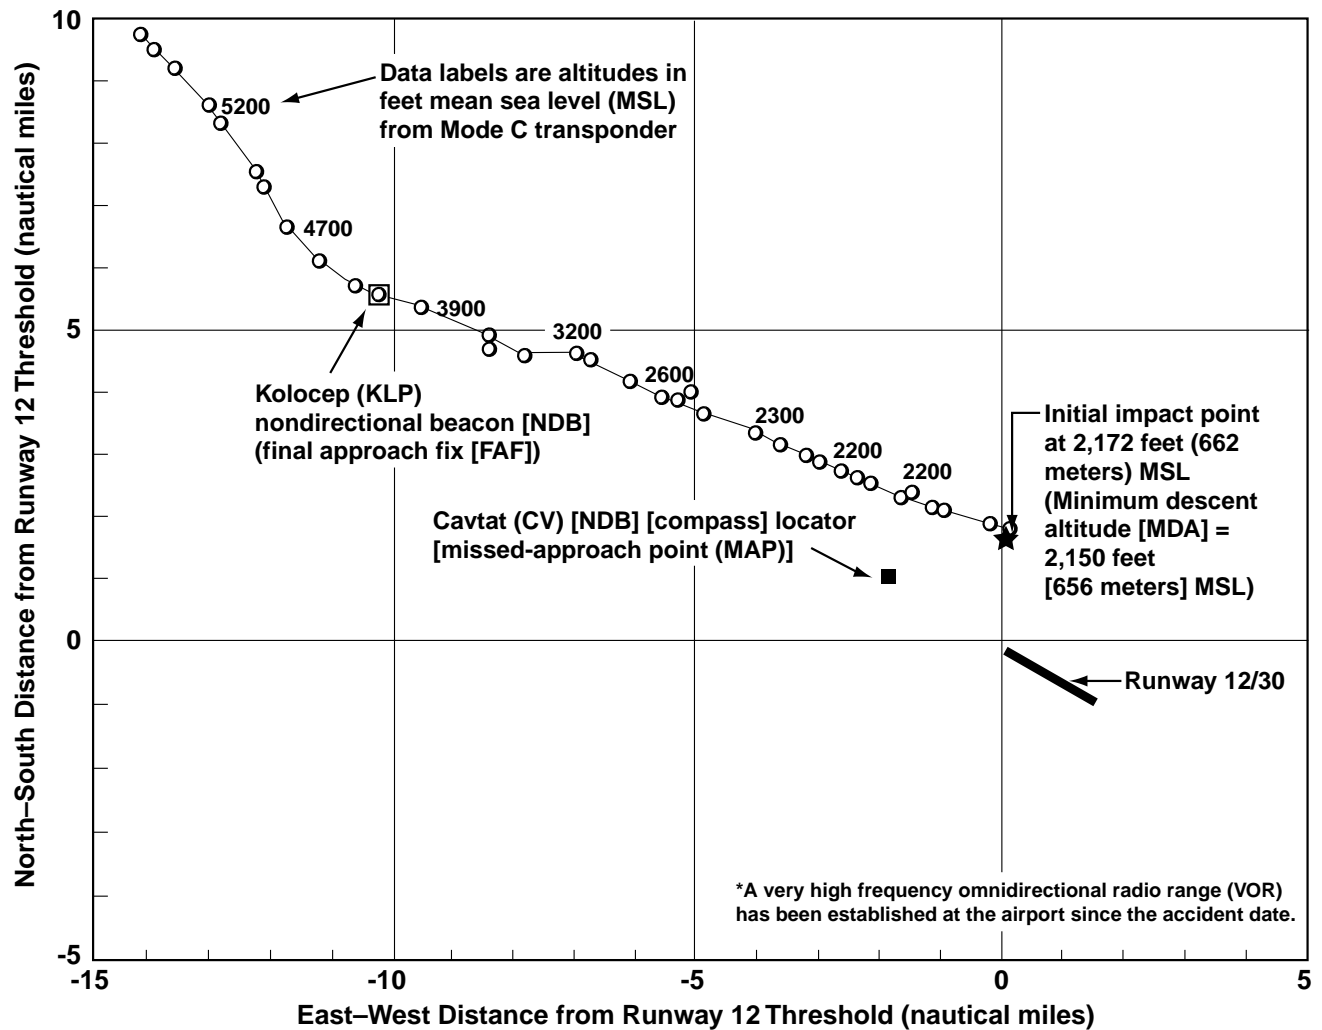
Figure 3

As the aircraft crossed the final approach fix (FAF), it had an airspeed of approximately 209 knots (387 kilometers per hour), which was 30 knots (56 kilometers per hour) faster than the airspeed recommended in the airplane's flight manual for crossing the FAF.

Reconstruction of Final Approach Flown by Accident Crew, U.S. Air Force CT-43A, Dubrovnik, Croatia, April 3, 1996

The report noted: “The flight manual also requires an aircraft to be fully configured with landing gear down and landing flaps extended when crossing the [FAF].” Based on these indicated airspeeds and the maximum flap airspeeds found in the flight manual, the [accident] aircraft’s flaps were not set for landing and would have been between the zero and 10 flap setting (normal setting for landing is flaps at 30).”

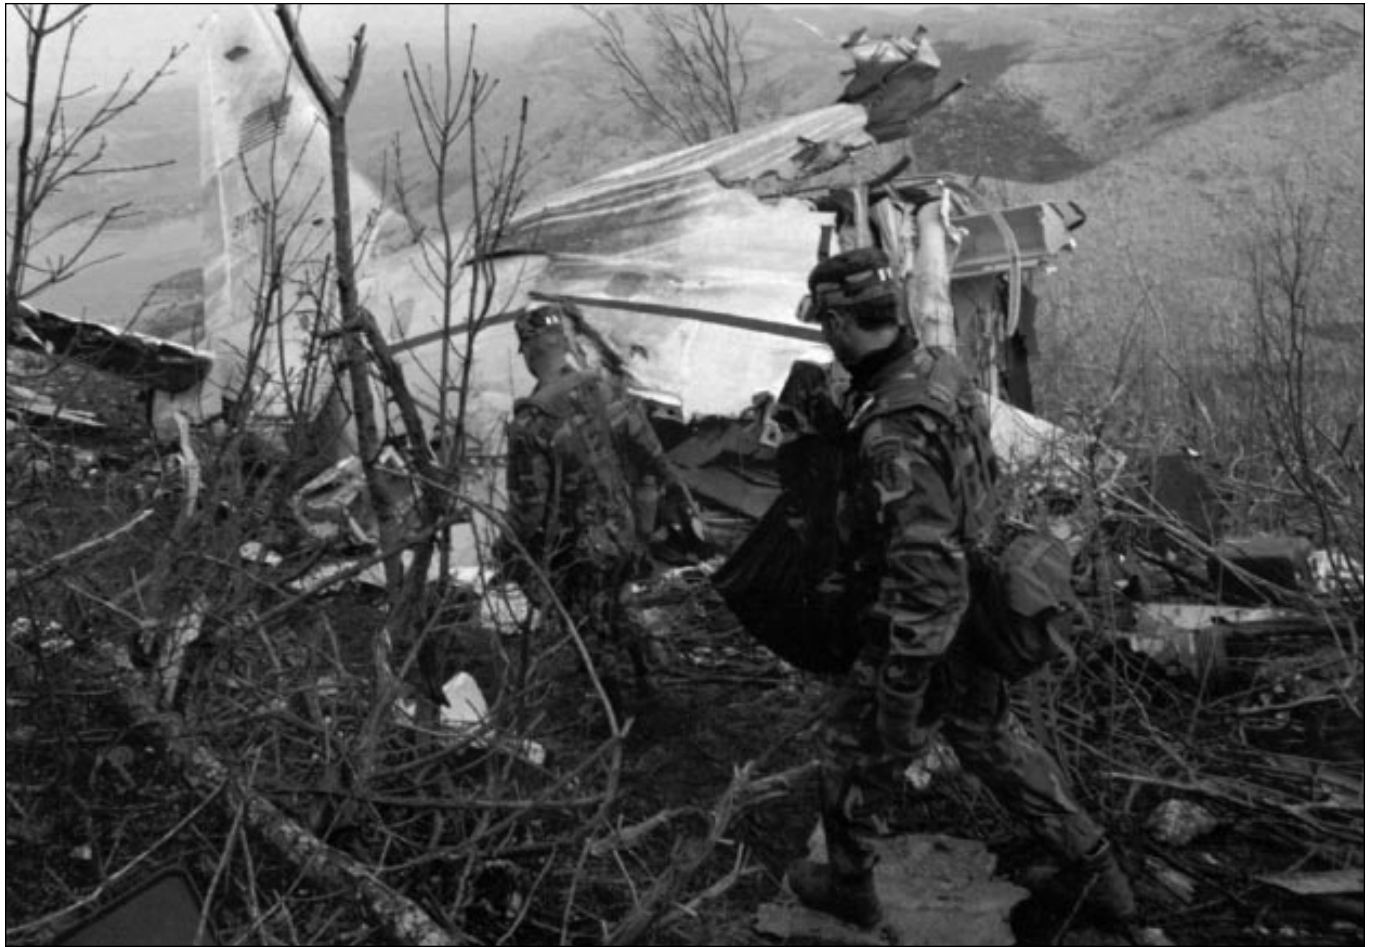
The empennage was located and found "upslope from the initial impact area and oriented on a heading of approximately 90 degrees," the report said. "It was upright but resting on its left side and the left horizontal-stabilizer tip due to the incline of the hill. This section [extended] from the forward

U.S. Army investigators walk toward wreckage of rear fuselage and empennage of U.S. Air Force CT-43A that crashed on approach to Dubrovnik, Croatia.

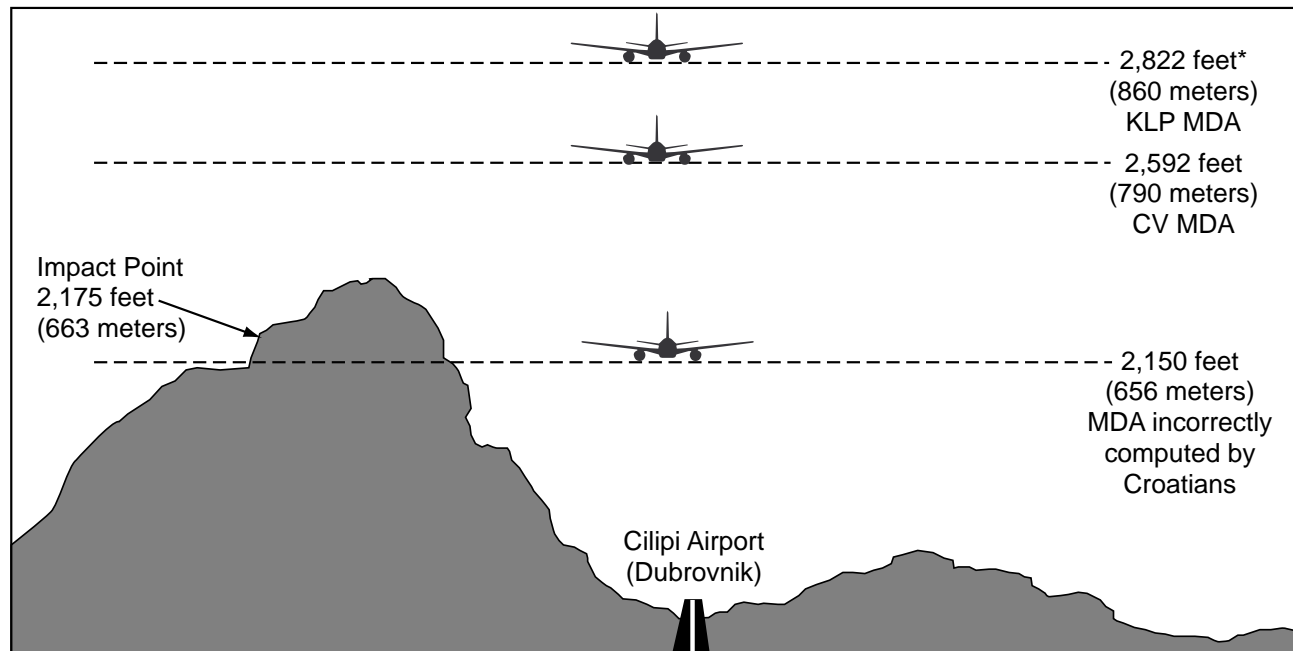
“Correct application of both the U.S. and [ICAO] standards would result in a higher [MDA] than published by the host nation”

Minimum Descent Altitudes (MDAs) Based on ICAO Criteria

* KLP and CV MDAs correctly computed by accident investigators using International Civil Aviation Organization (ICAO) criteria. [Editorial note: KLP and CV are nondirectional radio beacons (NDBs).]
